**National Construction Safety Team Reports on the WTC Investigation**

## EXECUTIVE SUMMARY

### E.1 GENESIS OF THIS INVESTIGATION

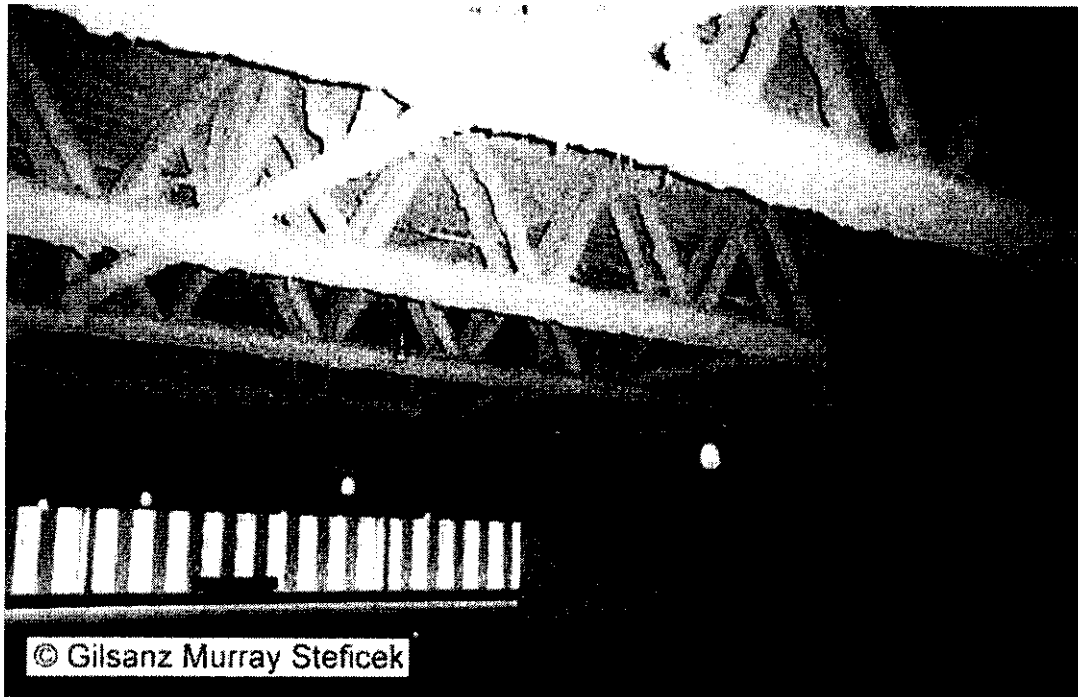
**Figure 1-8. Photograph of insulated WTC trusses.**

three different sprayed fire-resistive material (SFRM). In this report, these materials are collectively referred to as "insulation."<sup>4</sup> The thickness of the wallboard or the SFRM was selected to provide an intended level of thermal protection. Figure 1-8 shows the appearance of a floor truss with sprayed insulation.

Bare structural steel components, when exposed to a large and sustained fire, can heat rapidly to the point where their ability to support their load is compromised. Thus, insulation is usually employed to encapsulate the steel and thus delay the heating of the steel. In the WTC towers, a major fraction of the core columns were enclosed or protected on several sides by sheets of gypsum wallboard. The trusses, perimeter columns, spandrels, and one or more surfaces of the core columns were coated with one of
